## **Appendix C**

### **LMA-Specific Hazards and Projects**

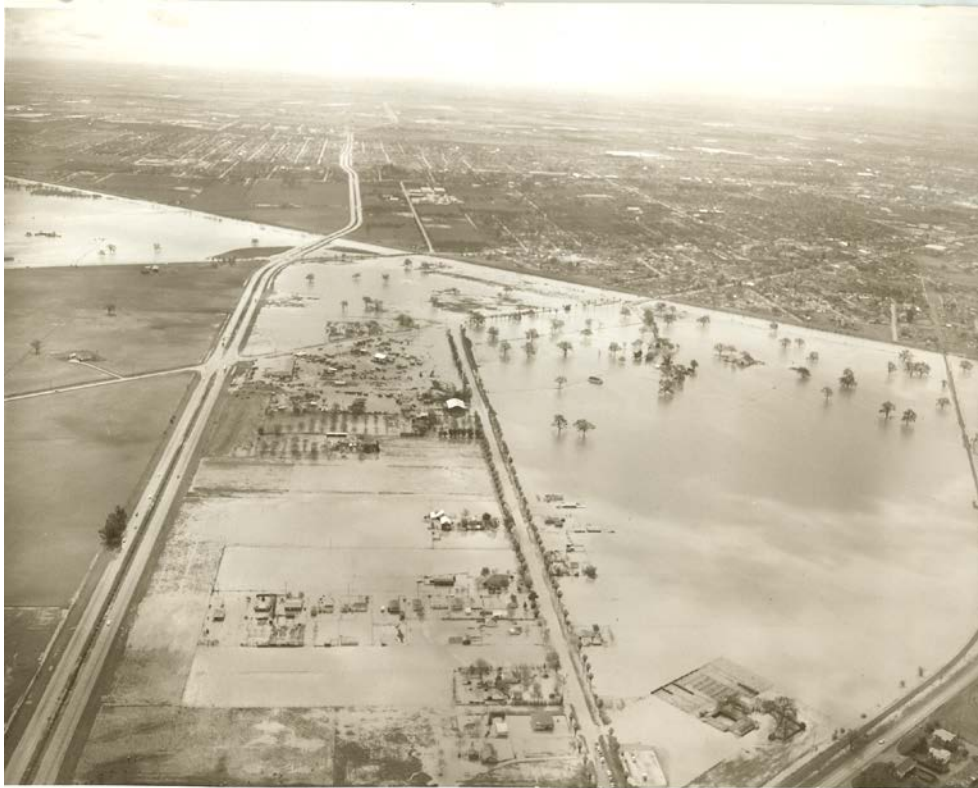
Similar, but less extensive, inundation of this area occurred during the 1958 flood as shown in the following photograph. Figure 7 shows the location and viewing direction from where the photograph was taken. The photograph generally looks south, with the left levee of the Stockton Diverting Canal forming the straight line across the top half of the photograph. The inundation area in the photograph is currently more developed than it was during 1958. The photograph was taken many years before building the right project levee.

1958 Inundation from Diverting Canal (see Figure 7 for location)

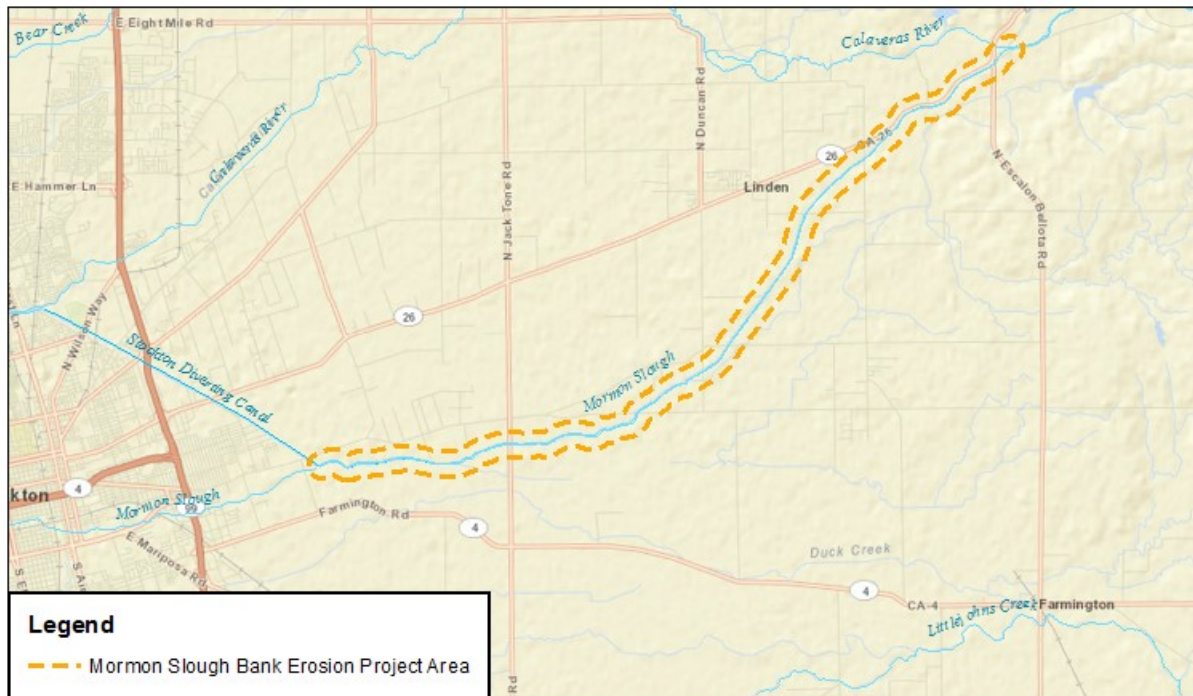
Mormon Slough has experienced bank erosion from several past flood events. This project aims to repair Mormon Slough along with preventative measures to mitigate future bank erosion from near Escalon-Bellota Road downstream to the Stockton Diverting Canal. Figure 11 shows the reach for bank erosion repair.

Figure 11 – Mormon Slough Bank Erosion Repair

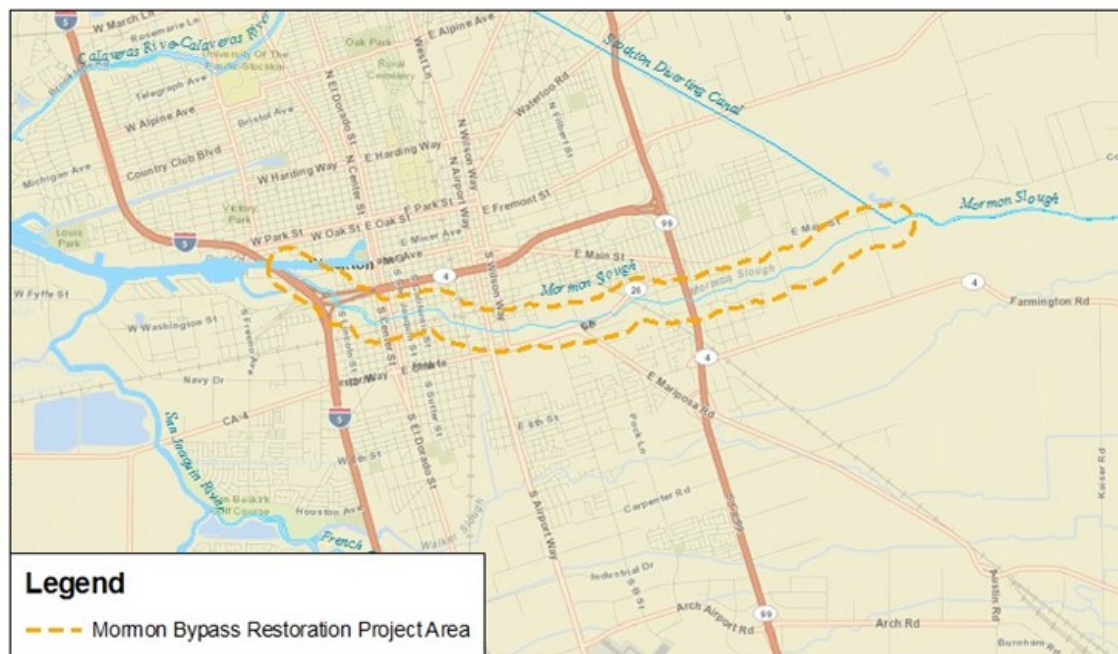
This project would divert up to 1,500 cfs to Mormon Channel via a weir at the head of the Stockton Diverting Canal, thereby reducing the flood flow in the Stockton Diverting Canal and the Lower Calaveras River below the Diverting Canal. This would reduce flooding potential of these systems and provide some resiliency to accommodate future climate change. Figure 12 shows the location of the Mormon Channel Bypass.

Figure 12 - Mormon Channel Bypass Restoration Project Area

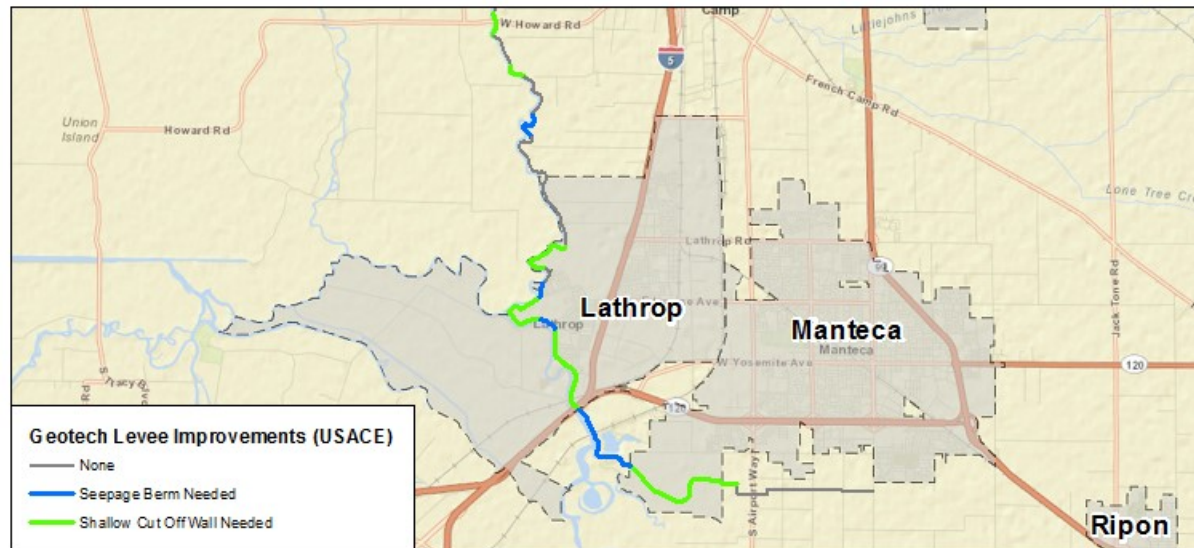
The RD 17 levees providing flood protection for the City of Lathrop were evaluated as part of the LSJRFS. A preliminary screening analysis was performed during the early stages of the LSJRFS which evaluated freeboard and geotechnical deficiencies. Levee geometry was evaluated, and didn't indicate any deficiencies along RD 17. The results of the preliminary screening analysis are shown in Figure 14 and Figure 15.

Figure 15 - RD 17 Geotechnical Deficiencies

The LSJRFS indicates that the levees along the west side of RD 17 have minor freeboard deficiencies and significant seepage issues. The dryland levee south of RD 17 has significant freeboard deficiencies. Note that other recent studies show no freeboard deficiencies for RD 17 along the San Joaquin River (see Appendix B).

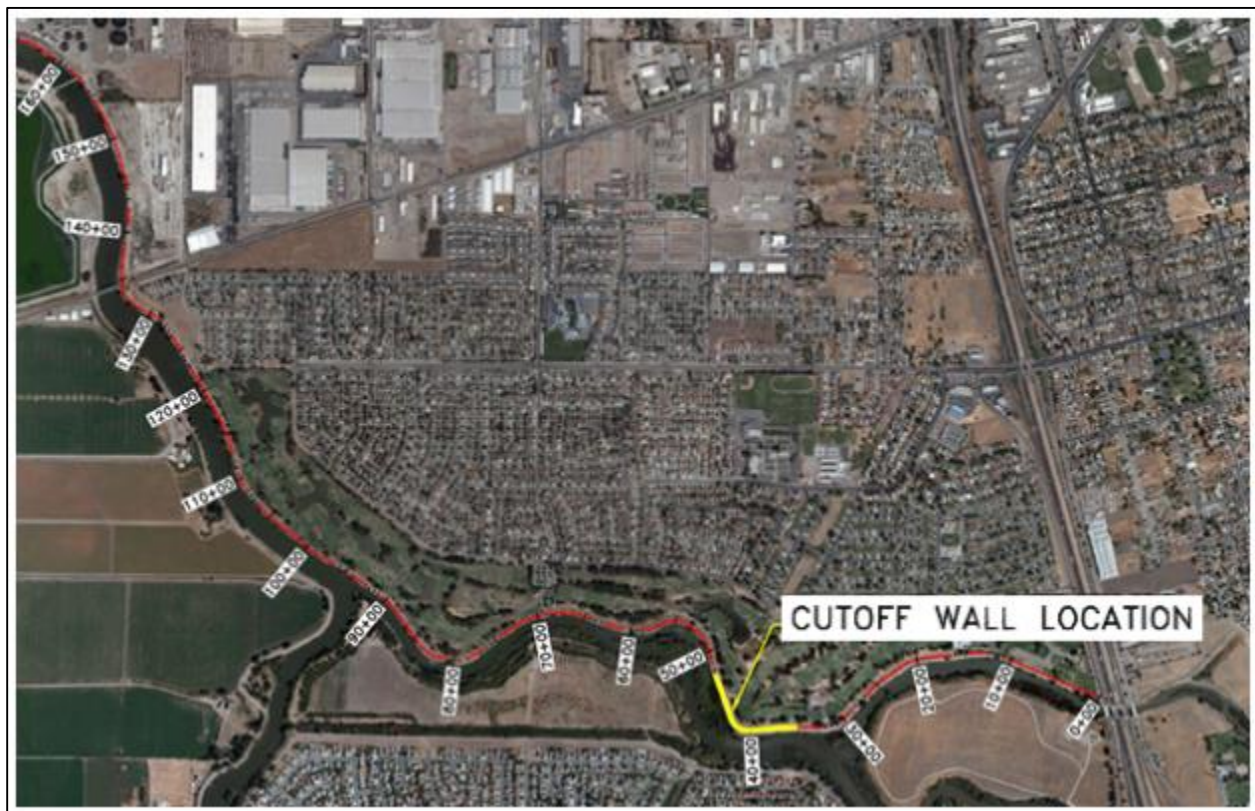
The right bank of French Camp Slough is prone to seepage. The District has identified the need for a cutoff wall along the right bank of French Camp Slough, just downstream of Walker Slough. The proposed cutoff wall would extend along French Camp Slough for approximately 1,200 feet. The approximate project limits are shown in Figure 22.

Figure 22 - Cut-off Wall along French Camp Slough

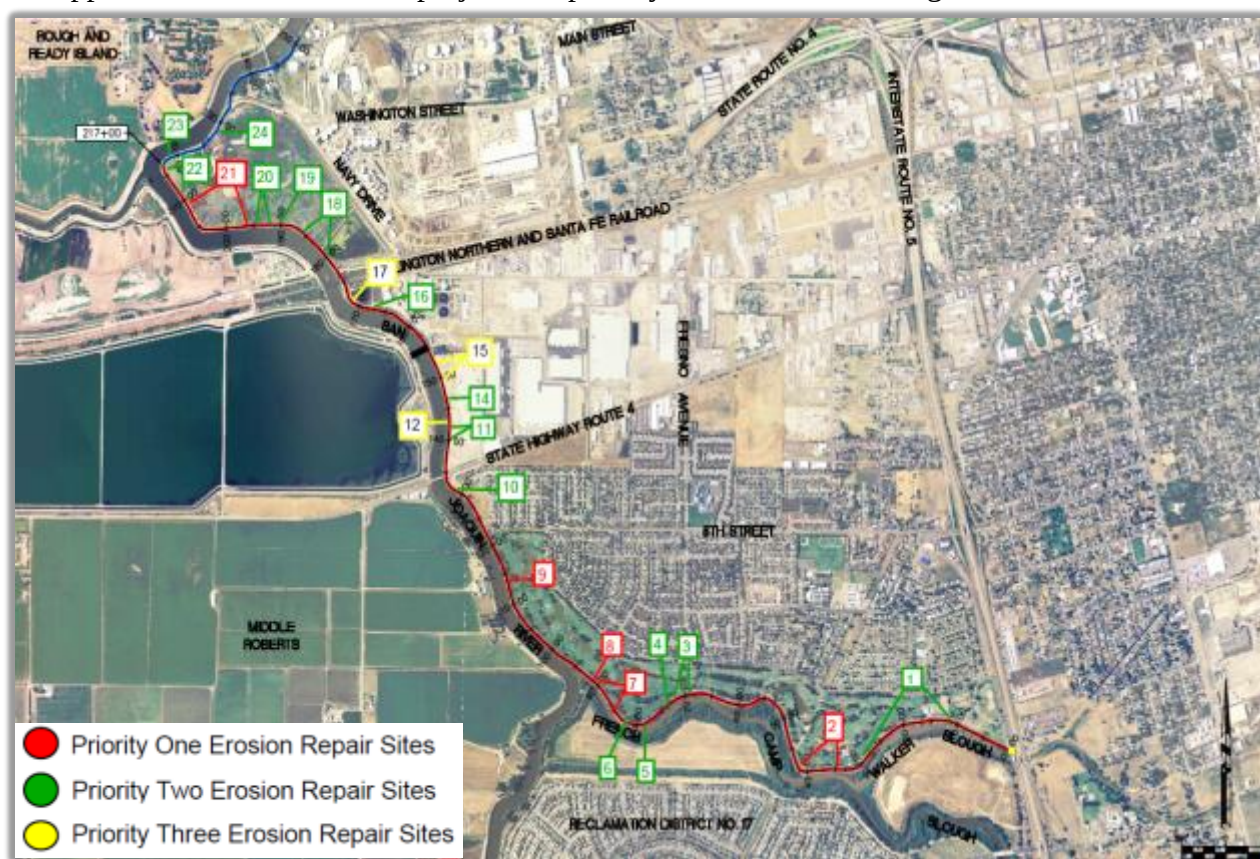
The projects have been broken down into three priority levels. Priority 1 contains approximately 2,430 lineal feet of riprap, with an estimated cost of \$215,000. Priority 2 contains approximately 4,200 lineal feet of riprap, and is estimated to cost \$336,200. Priority 3 contains approximately 350 lineal feet of riprap, with an estimated cost of \$28,250. Thus, the project will have a total cost of approximately \$579,500. The priorities indicate the order of the projects (Priority 1 first) – but all will be completed within the next few years and included in the RFMP Tier 1 projects. The approximate location of the project and priority areas is shown in Figure 23.

Figure 23 - Erosion Protection along RD 404 Levees

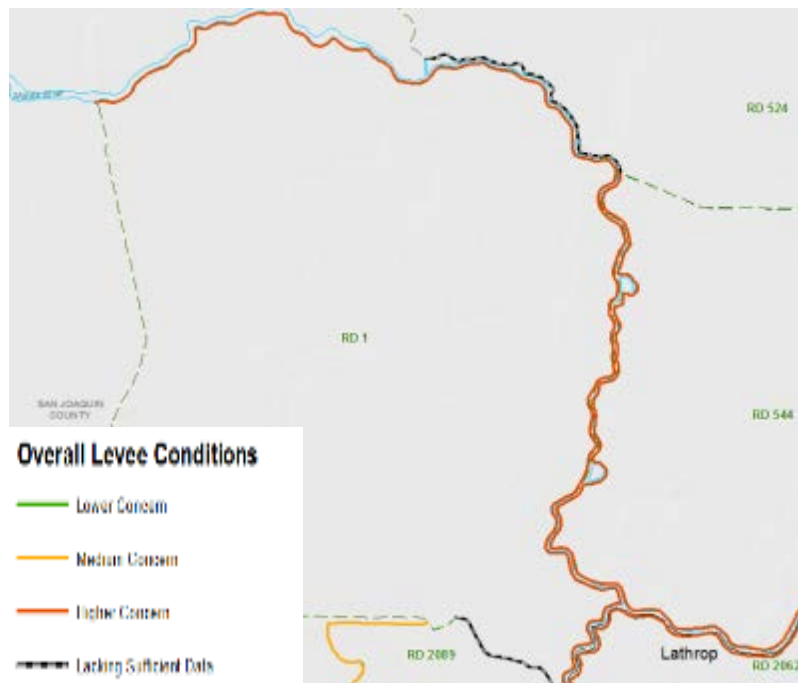
The 2012 CVFPP identified seepage, erosion, and slope stability concerns with levees in the Regions based on the NULE evaluations. Figure 39 presents the Overall Hazard Level of levees around RD1.

Figure 39 - CVFPP Overall Levee Conditions RD 1
